LANDSLIDE SUSCEPTIBILITY IN THE WILLIAMSPORT 1- BY 2-DEGREE QUADRANGLE, PENNSYLVANIA

Environmental Geology Report 9

by Helen L. Delano and J. Peter Wilshusen
Bureau of Topographic and Geologic Survey

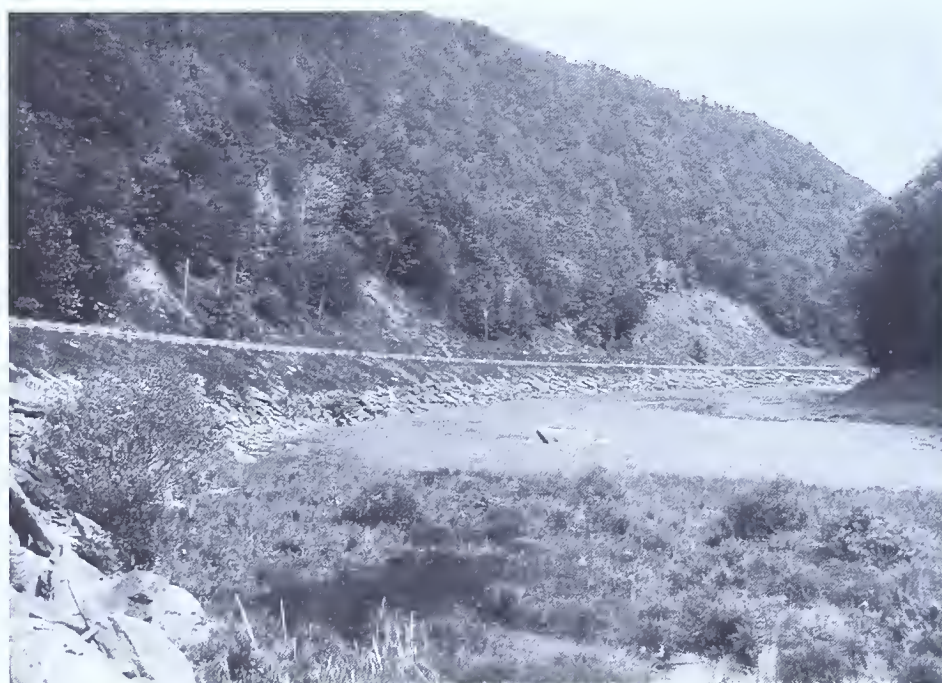
Figure 3. Kettle Creek valley is typical of the steep-sided stream valleys in the Deep Valleys section of the Appalachian Plateaus province.

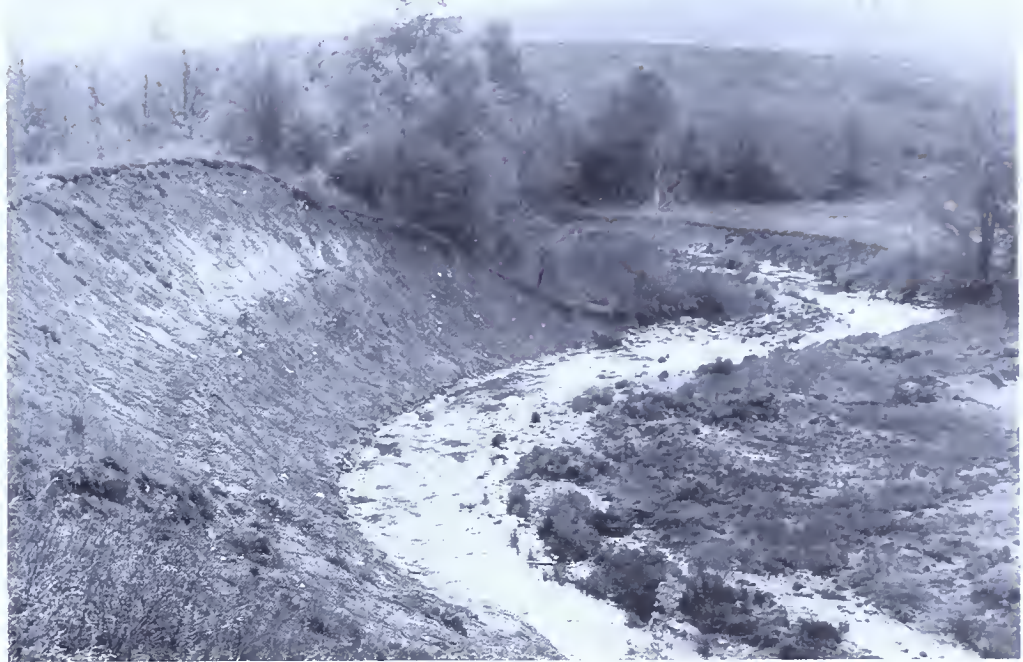
Figure 4. North Elk Run (Mansfield 7.5-minute quadrangle) flows through a terrain representative of the Glaciated Low Plateau section. Stream action has triggered landslides in the unconsolidated glacial clay, sand, and gravel along the valley sides. In the background, the stream flows on flat-lying shale and siltstone bedrock.

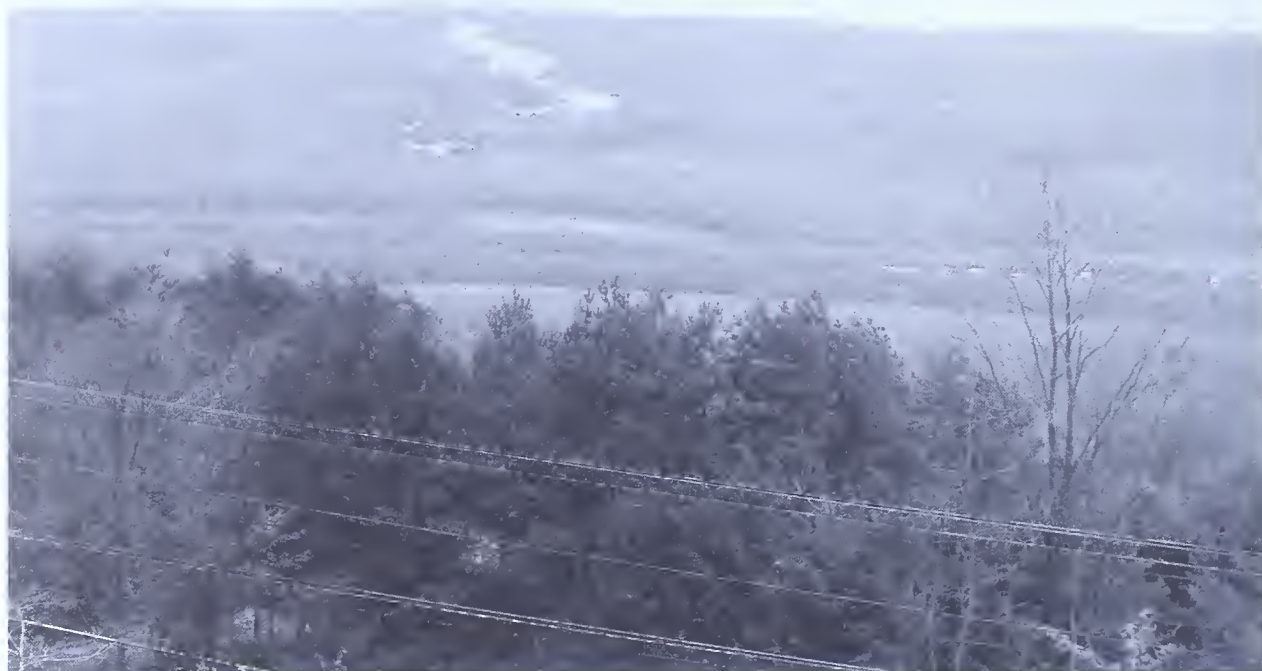
Figure 5. The north slope of Bald Eagle Mountain and the valley of the West Branch Susquehanna River exemplify the Appalachian Mountain section of the Ridge and Valley province. The unforested boulder field in the background is suggestive of a debris slide, but boulder fields such as this are presently stable.

Figure 5 shows a landscape typical of the structurally folded, linear ridges and valleys of the Appalachian Mountain section. Generally forested ridges

separate cultivated valleys. Landslides occur mostly on lower slopes in colluvium and along stream banks. Large, unvegetated boulder fields (Figure 5) occur locally on the mountainsides. Although their outlines are suggestive of debris slides, they are stable slopes if left undisturbed, due to a composition of interlocking, angular boulder fragments that have weathered from the ridge above and accumulated as boulder fields containing very little fine-grained interstitial rock material and soil (Figure 6). The boulder fields are free draining and have little opportunity for a buildup of pore pressure. These striking hillside features are believed to have developed in a periglacial climate near the edge of a continental ice sheet. The lower slopes of some ridges are mantled with thick clay-rich colluvium that is prone to sliding if disturbed.

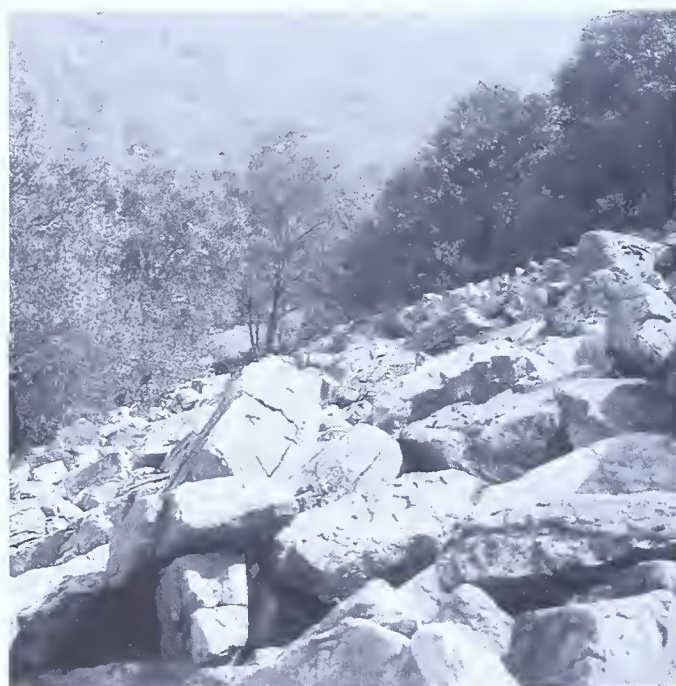
Figure 6. Coarse boulder colluvium forming a boulder field on a 42-degree (90-percent) slope in the Appalachian Mountain section of the Ridge and Valley province. Interlocking angular boulders, having no appreciable amount of fine rock fragments or fine-grained soil, form a freely draining slope that is stable if left undisturbed.

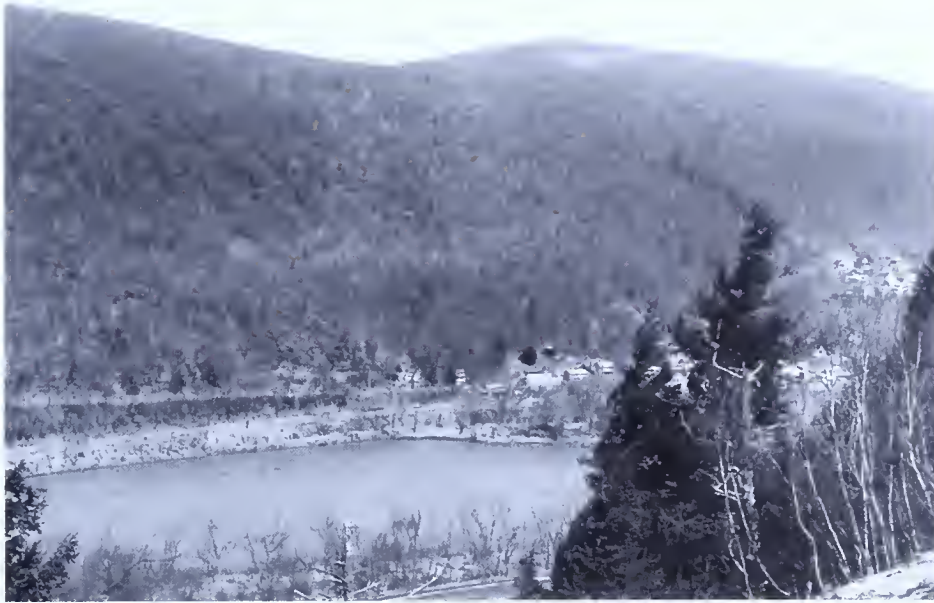
Figure 7. Shickshinny Mountain and the Susquehanna River are representative of the terrain in the southwestern portion of the Northern Anthracite region. The steep slope bordering a major stream valley and the glacial deposits on the lower slopes are a setting for potential landslides. Landslide occurrences are often related to highway and railroad construction in constricted areas.

The third subdivision, the southwest extension of the Northern Anthracite region, extends from Nanticoke to Knob Mountain northwest of Berwick. Here, highway and railroad transportation routes are crowded along a narrow river valley (Figure 7) below steep slopes. Although this subdivision is a small part of the project area, it is important with respect to landslide susceptibility. The major river cutting through a large bedrock fold and the later deposition of thick, unconsolidated glacial deposits produced a number of poten-

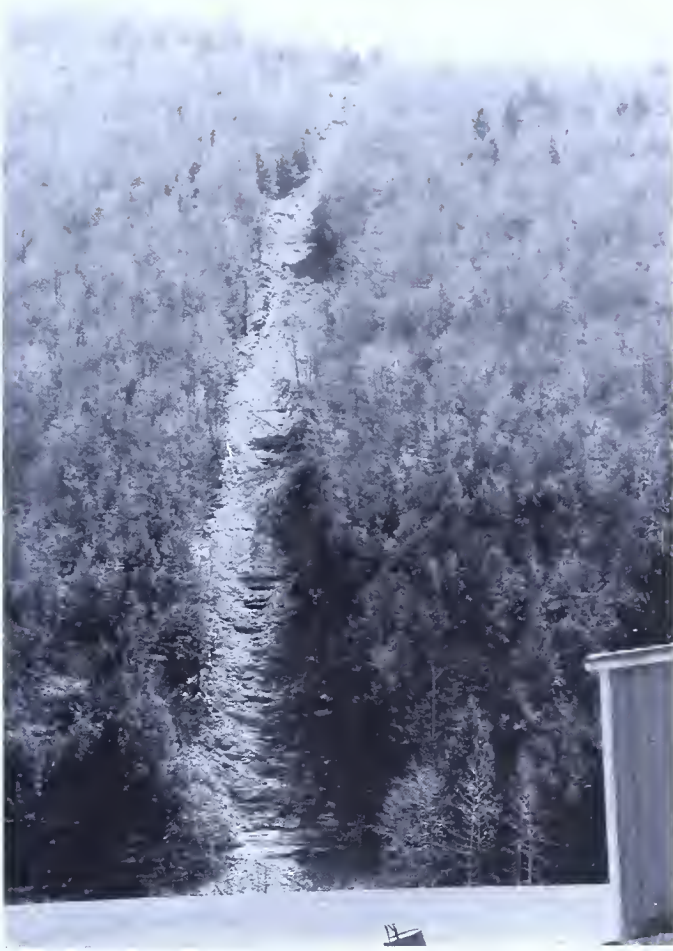
Figure 10. A debris avalanche, triggered by heavy rain, has left a long, narrow scar on a steep hillside and an accumulation of rocky debris along the stream at its toe. Regrowth of vegetation on the scar and stream erosion of the deposit at the toe will conceal evidence of this slide after several years. The site is at the Stevenson Dam on First Fork, just outside the western border of the Williamsport map area. Debris avalanches commonly occur in narrow valleys.

Debris avalanche (Figure 10) is the rapid downhill movement of a combination of soil and rock along a planar surface. The resulting scar is generally long and narrow, leaves a channel, or chute, on a hillside, and has an accumulation of debris at the toe. Debris avalanches are the result of rapid to extremely rapid movement at a rate greater than 10 feet per second. Although none were observed in motion to verify their

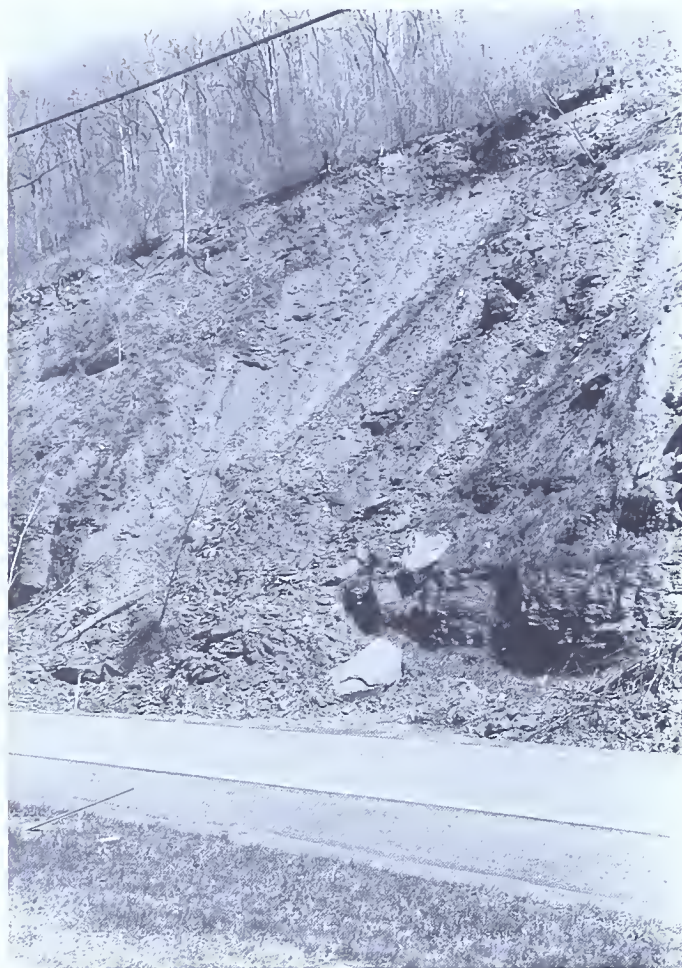
Figure 12. Debris flow in colluvium and residuum on sandstone and shale of the Catskill Formation in the Sinnemahoning Creek valley.

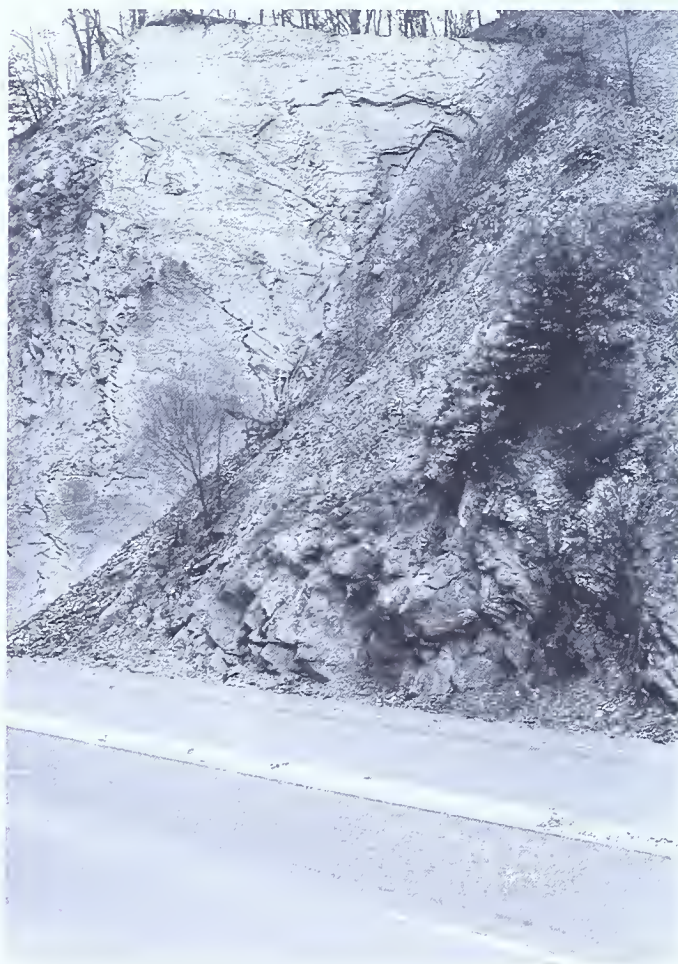
Figure 14. A small slump block that is part of a larger composite rockslide and debris slide on the Huntersville 7.5-minute quadrangle. The orientation of the originally upright trees clearly shows the rotational movement.

Slump (Figures 14 and 15) is rotational sliding in which the surface of rupture is a concave-upward shear surface or zone. The axis of rotation is horizontal and generally parallel to the trend of the slope on which failure occurs. The head of a slump tilts back into the slope and the toe characteristically rises, spilling out over undisturbed ground along a surface of separation (Figure 15). The least distortion of the sliding mass is at its head, whereas the greatest distortion is at the toe. Individual slumps commonly form segments of larger composite landslides or may exist by themselves as small discrete slope failures along a hillside. Slump can occur in rock or soil, but it is most common in uniform fine-grained material. The absence of planar weak surfaces such as bedding or fracture discontinuities allows development of the concave slip surface. Progressive slump failure occurs

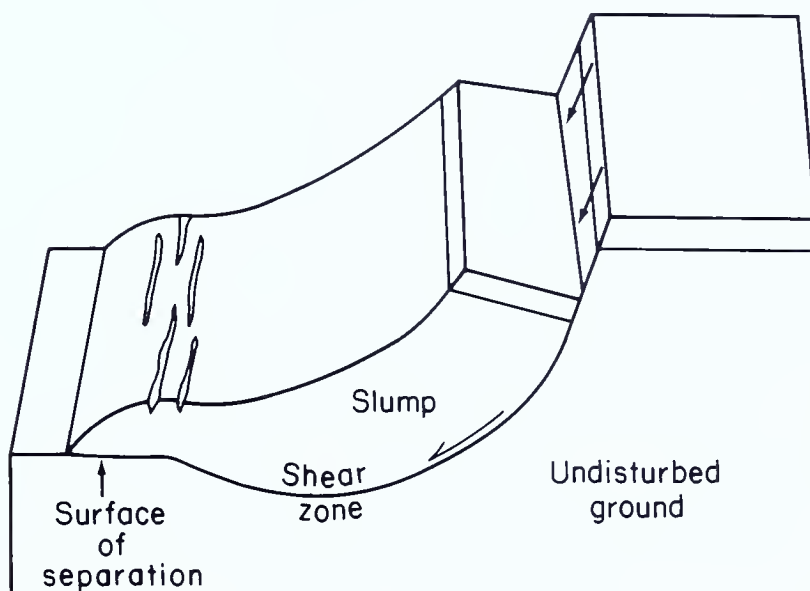
Figure 15. The mechanism of slump failure. The shear zone is concave upward. The head of the slide is tilted back toward the slope, and the material at the toe moves out and upward.

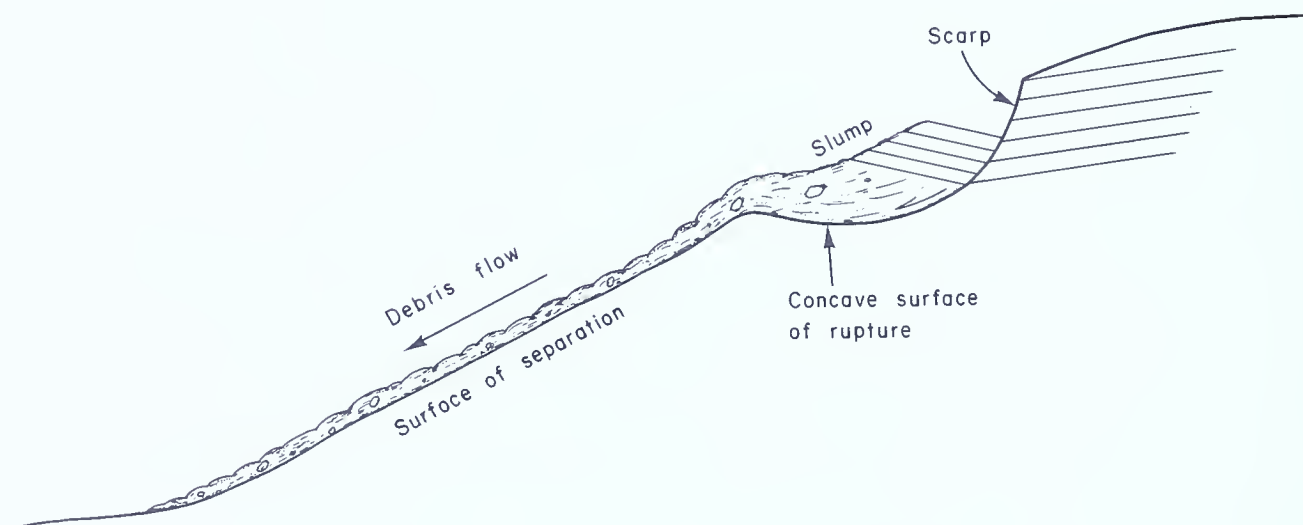
Figure 16. Schematic cross section of a combination of slump and debris flow.

The landslide deposit of a slump failure commonly continues past the toe of the curved surface of rupture and moves farther downslope as an earthflow or debris flow. Figure 16 is a schematic cross section of this type of movement, showing a slump scarp and a deposit extending as a debris flow along a surface of separation between undisturbed ground and the flow. Failure is by rotational sliding in the upper part of the slide, and grades into flow below the slump. A slump-earthflow in glacial till is illustrated in Figure 17.

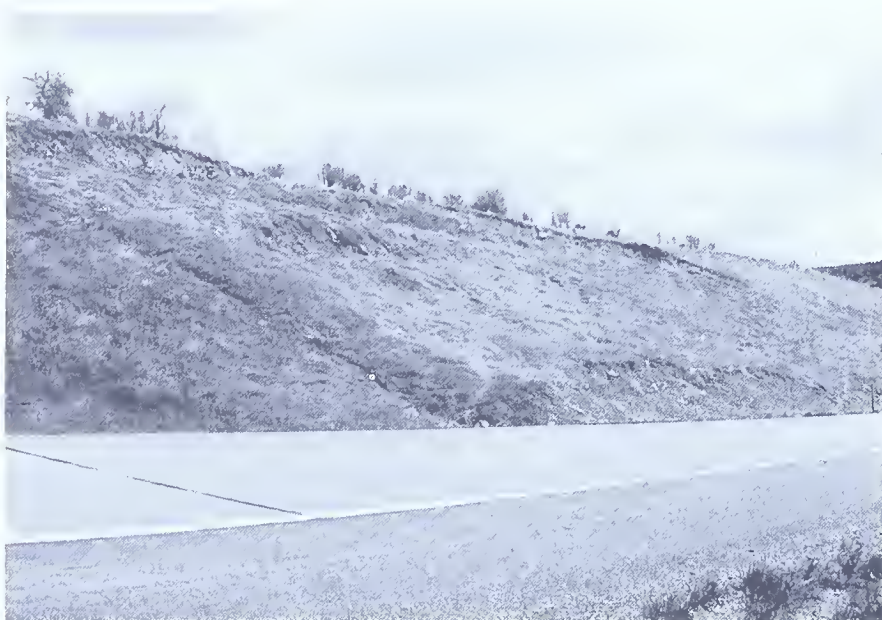
Figure 17. Slump-earthflow in glacial till in a recent highway cut along U.S. Route 15 north of Mansfield.

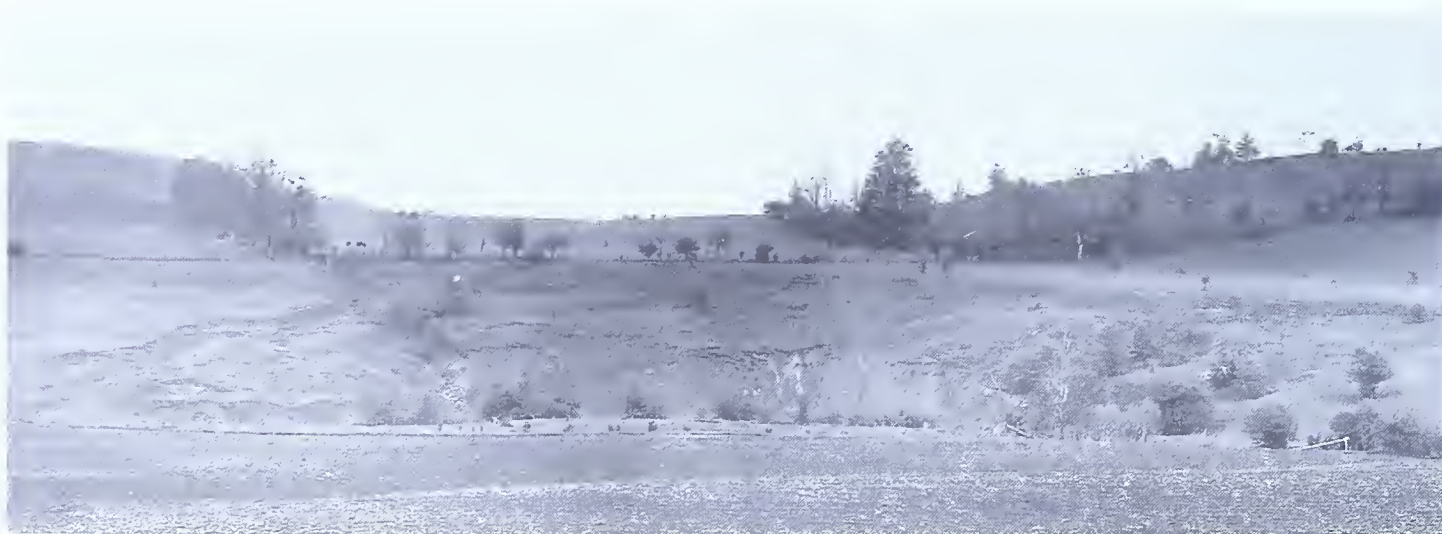
Figure 18. Old slump in glacial-lake clay along North Elk Run west of Mansfield.

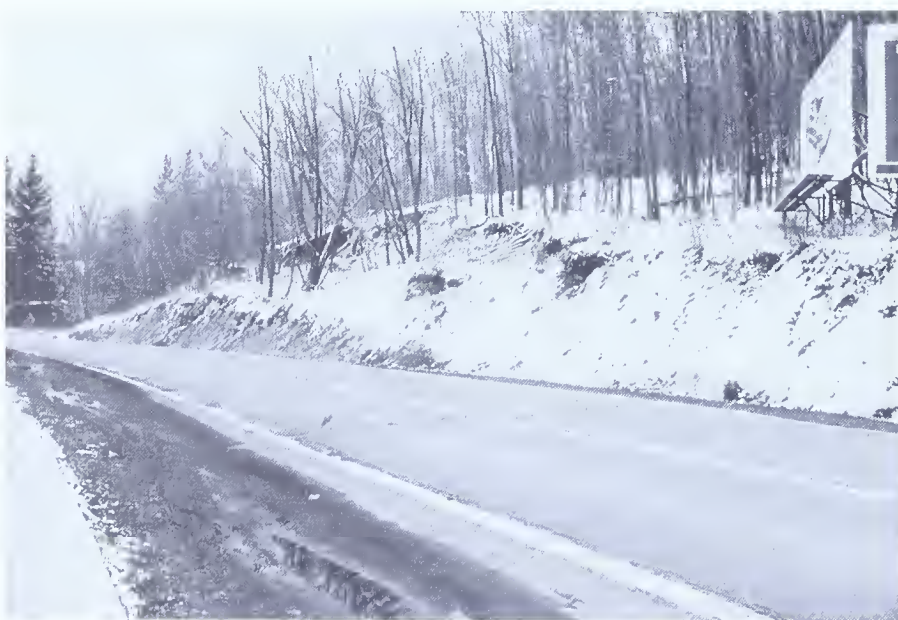
Figure 22. The toe and lower scarp of the Galeton slide. The light snow cover emphasizes the multiple scarps.

Figure 21 is a sketch map and cross section of this slump, which is approximately 300 feet long and about 535 feet wide at the toe, faces south-southwest, and has a slope of between 25 and 30 percent. The elevation at the toe is 1,370 feet; total relief on the slide is approximately 80 feet. It occurs near the base of an 800-foot-high slope above Pine Creek that is wooded, having small (1 to 12 inches in diameter) deciduous trees. Figure 22 is a photograph taken from U.S. Route 6, looking northwest across the slide.

removed to keep the road clear. X-ray diffraction analysis of the clay indicates the presence of smectite. A sample of the clay was analyzed for engineering strength properties, and the results are on file at the Pennsylvania Bureau of Topographic and Geologic Survey in Harrisburg. Above the clay, red-brown till is exposed; the uppermost section of the slide occurs in colluvium or colluviated till. The slide body is a series

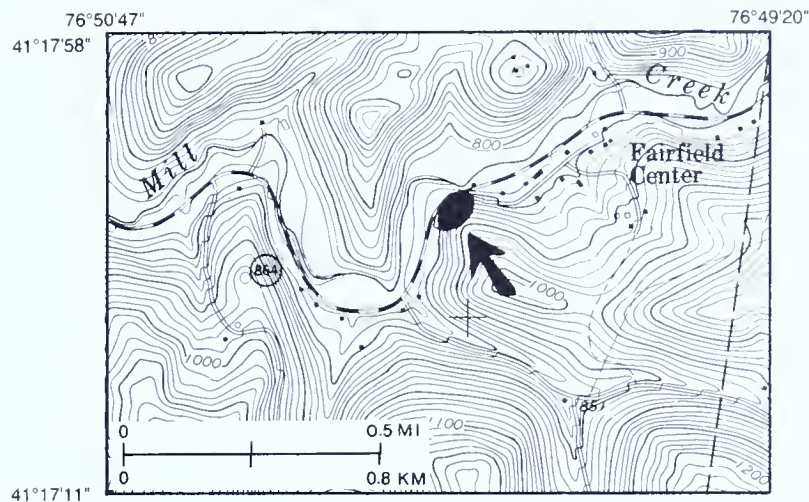
Figure 23. Location of the Huntersville rockslide and debris slide.

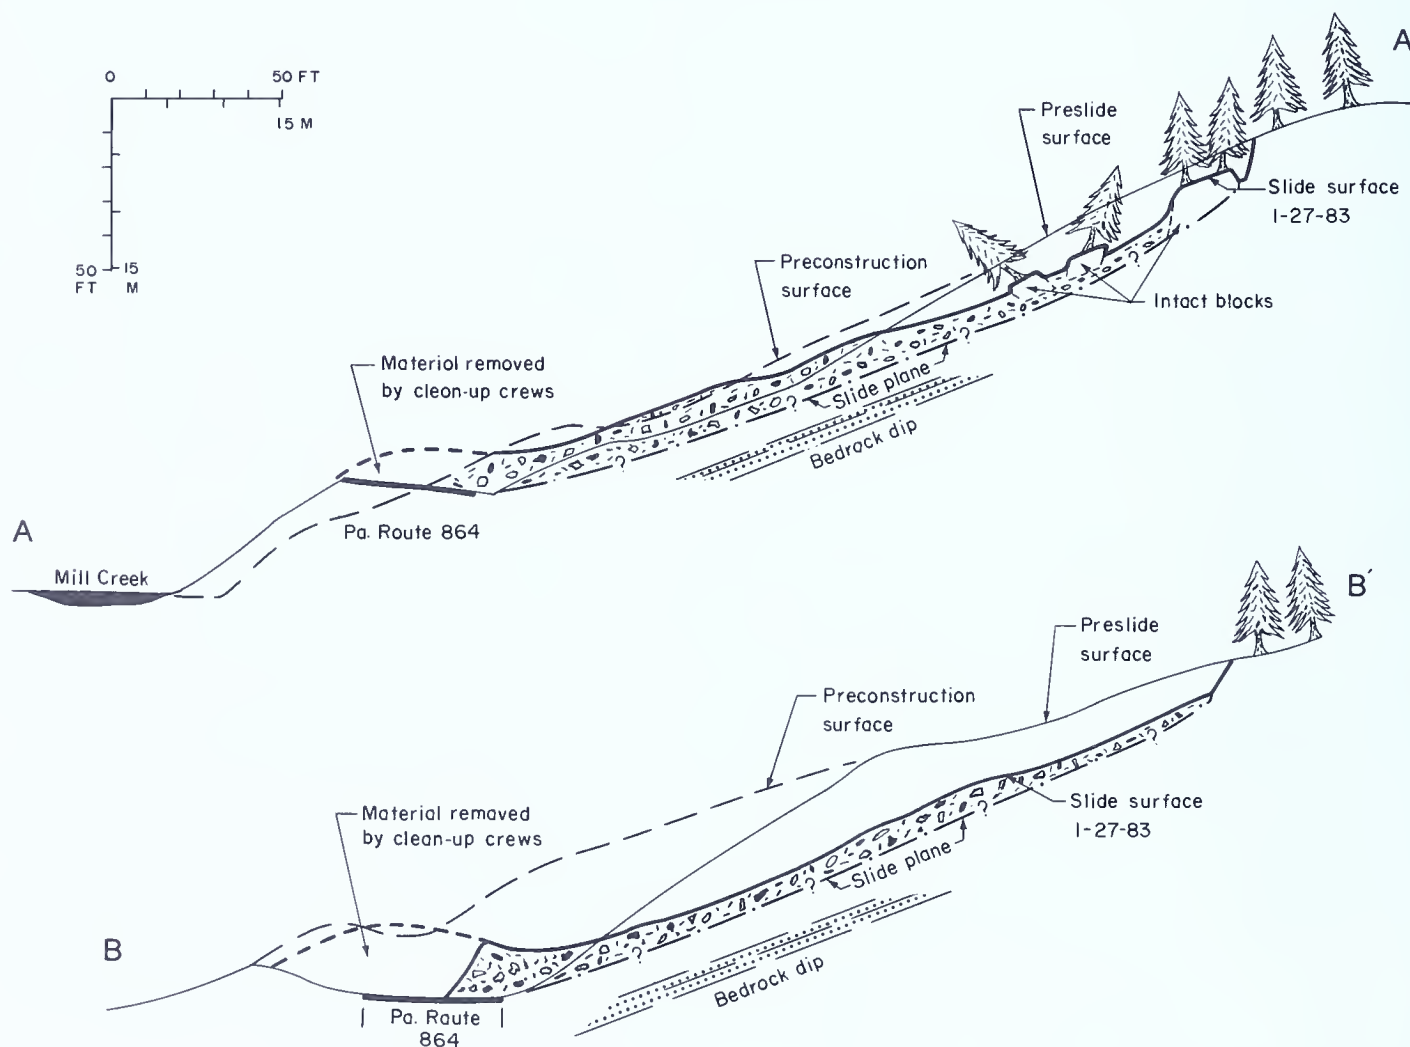
Figure 25. Cross sections of the Huntersville slide. Locations of cross sections are shown in Figure 24.

The bedrock involved is sandstone, siltstone, and shale of the Catskill Formation, approximately 550 feet stratigraphically above the base of the formation. Attitudes of N85°E, 25°NW and N73°E, 22°NW were measured at the head and toe of the slide (Figure 24). Approximately 2 feet of yellowish-brown channery silt loam overlying the rock is exposed in the head scarp. No evidence of any surface water or groundwater concentration was observed. One inch of rain was reported locally on January 10 and 11. The adjacent wooded slopes are steep, ranging from 28 to 35 degrees (53 to 70 percent slope). The bedrock at the toe of the slide area had been cut when the road was relocated in 1980 (Figures 24 and 25).

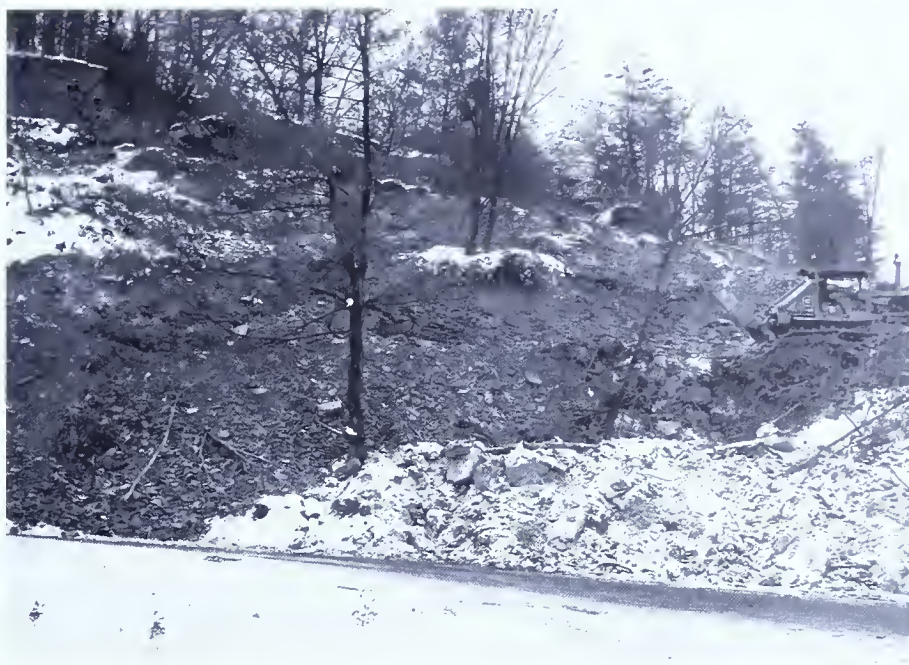
Figure 26. Large tree-covered blocks on the upper portion of the Huntersville slide. A bulldozer to the right gives approximate scale.

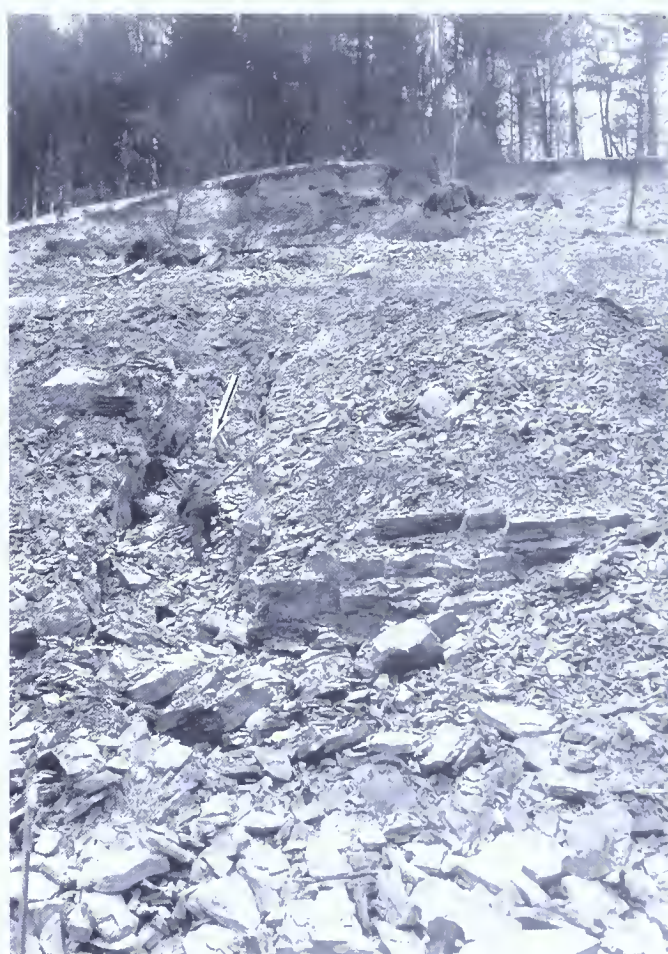
Figure 27. Photograph of the central portion of the Huntersville slide. The large, partially debris-covered blocks (on either side of the person indicated by an arrow) have moved. Note the variation in size of rock fragments.

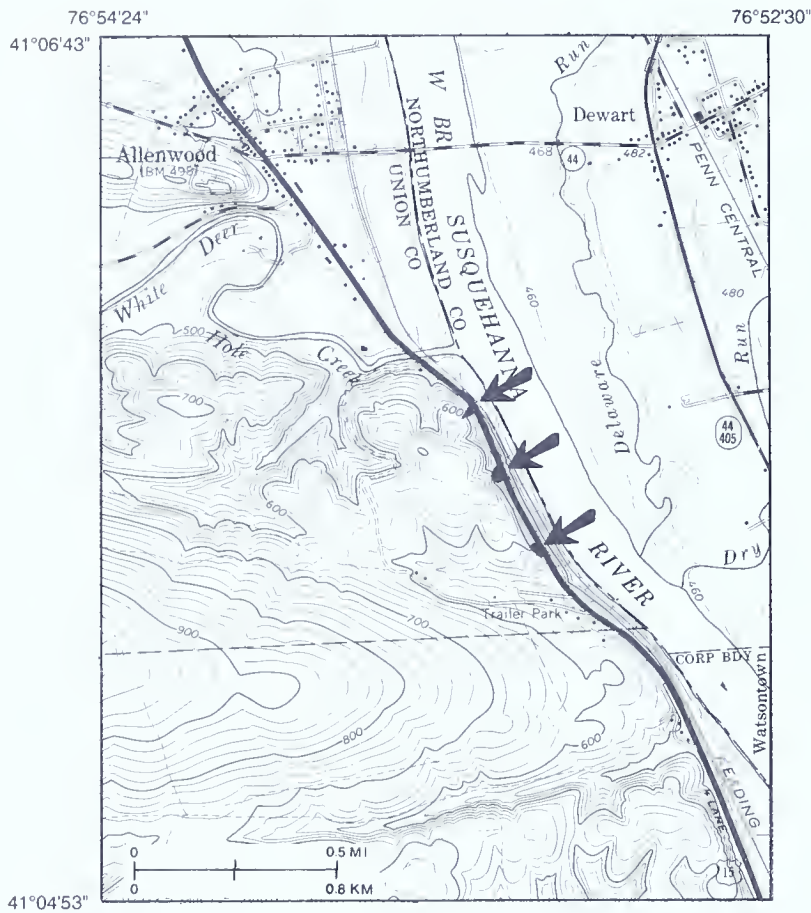
Figure 28. Location of rockslides near Allenwood.

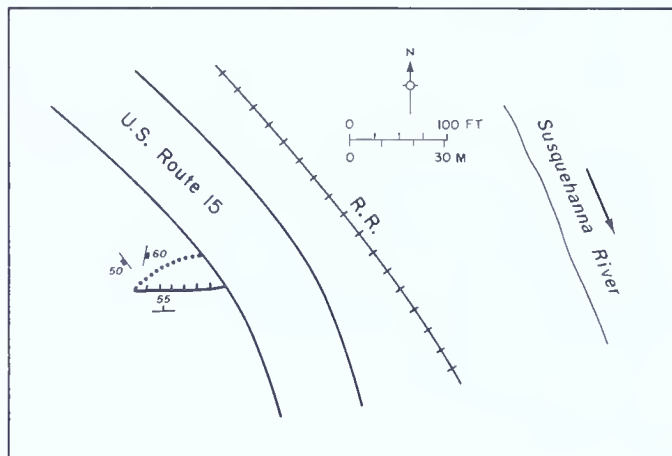
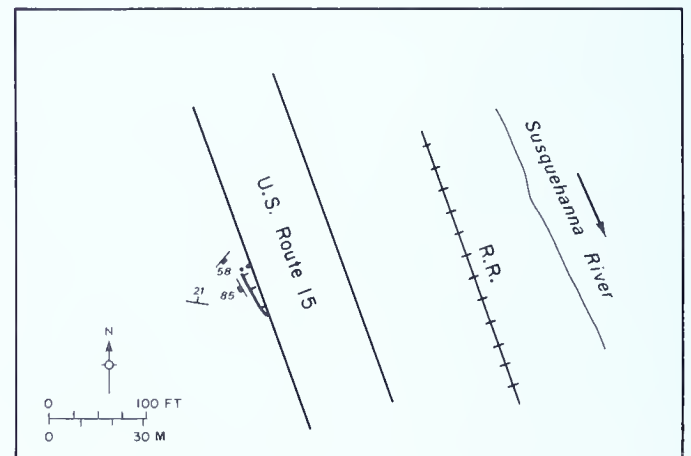
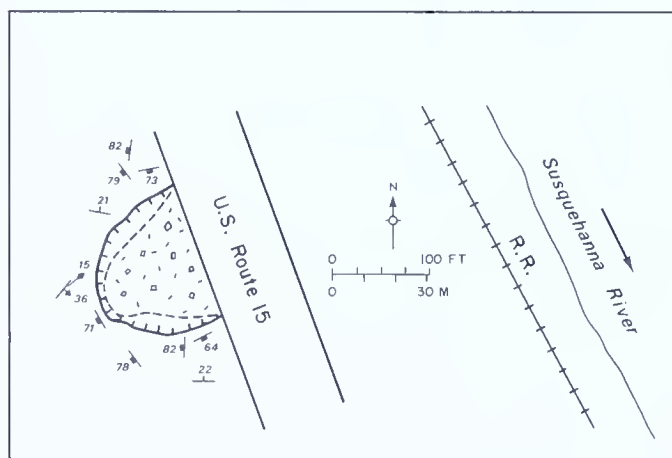
Figure 29. Sketch maps of individual rockslides near Allenwood (modified from unpublished data). Top left, wedge failure; top right, rock topple; bottom left, recurrent rockslide.

from their data. The dimensions of the slides shown in Figure 29 reflect the conditions that existed at the time of their study.

The wedge failure (shown in Figure 13) at the north end of the cut is about 150 feet long and 25 feet wide at the road edge. The wedge axis plunges 42 degrees toward N46°E. The recurrent rockslide (Figure 32) is approximately 75 feet long and 120 feet wide, and has a head scarp about 15 feet high. The slope of the debris surface became 35 degrees following removal of the loose material blocking the highway. This site has been a problem since shortly after the road opening. In 1970, the southbound lanes were closed after large cracks were observed in the shale. PennDOT removed much of the loose material by blasting, creating the general configuration of the present slope. Repeated rockslides forced closing of the highway in January 1974 and May 1983. Although the slide area is now partially stabilized, the near-vertical head scarp in fractured rock is a potential site for further sliding.

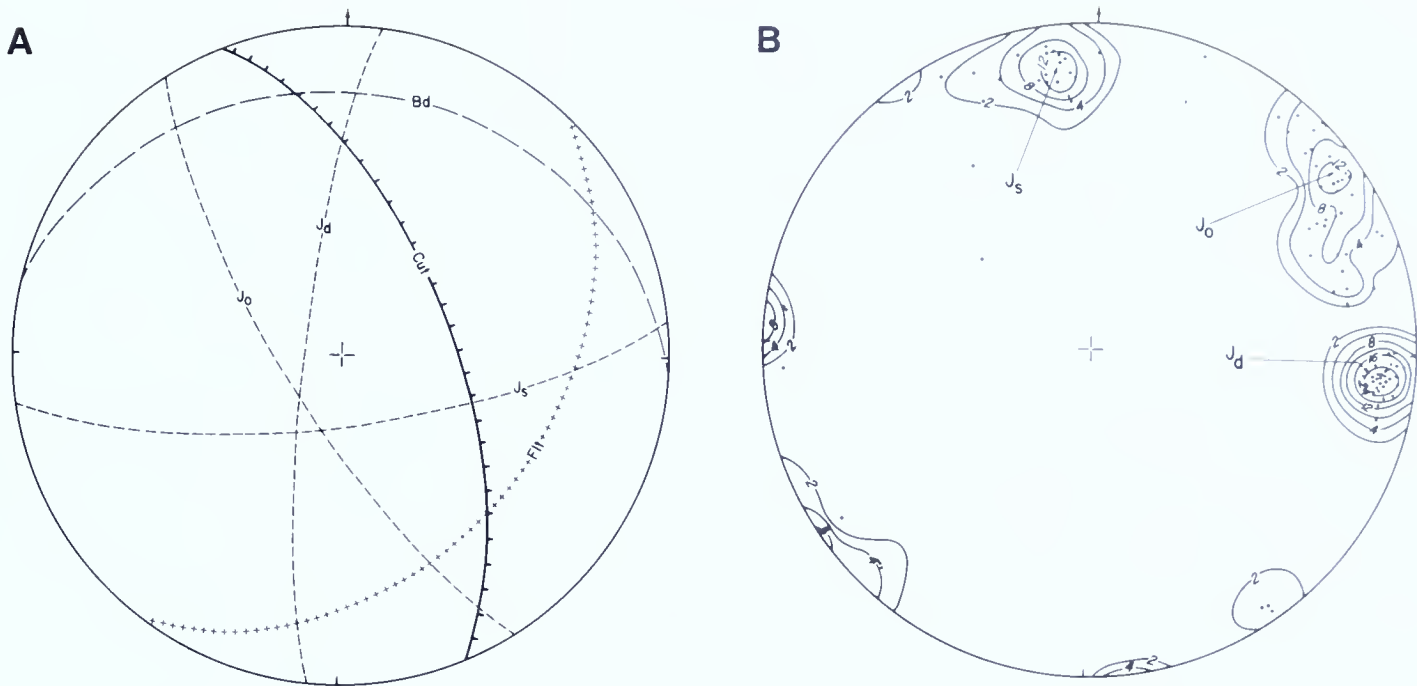
Figure 30. Stereograms (equal-area lower hemisphere projections). A. Discontinuity planes in shale at the site of a large recurrent rockslide near Allenwood (from Inners, 1997, p. 94). Bd, bedding (N82°W, 21 degrees NE); J_s , strike joints (N82°E, 73 degrees SE); J_d , dip joints (N6°E, 81 degrees NW); J_o , oblique joints (N33°W, 76 degrees SW); Flt, fault (N42°E, 36 degrees SE). The cut face shown in the diagram (N22°W at 1/2:1, or 63 degrees slope to the northeast) is the slope angle prior to attempted rehabilitation in the fall of 1970. B. Contour diagram of the poles of 100 joints at the Allenwood cut (from unpublished data). Contours are at 2, 4, 8, 12, 16, and 24 percent per 1 percent area. J_s , strike joints; J_d , dip joints; J_o , oblique joints.

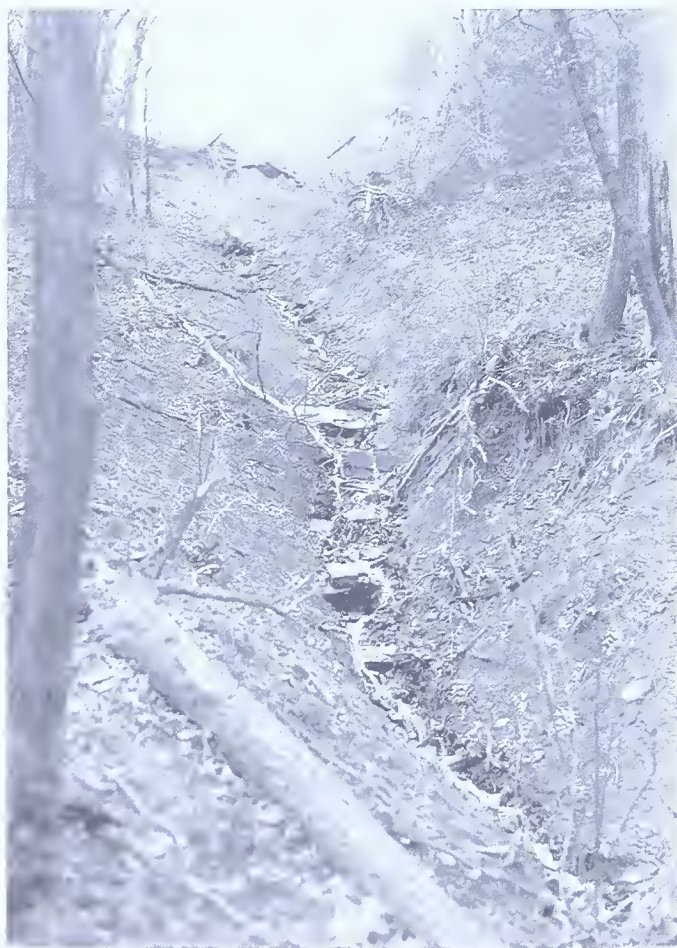
Figure 35. Photograph looking up through the central "chute" portion of the Torbert slide at the lower part of accumulated slumped material. Sandstone layers may be bedrock or large debris.

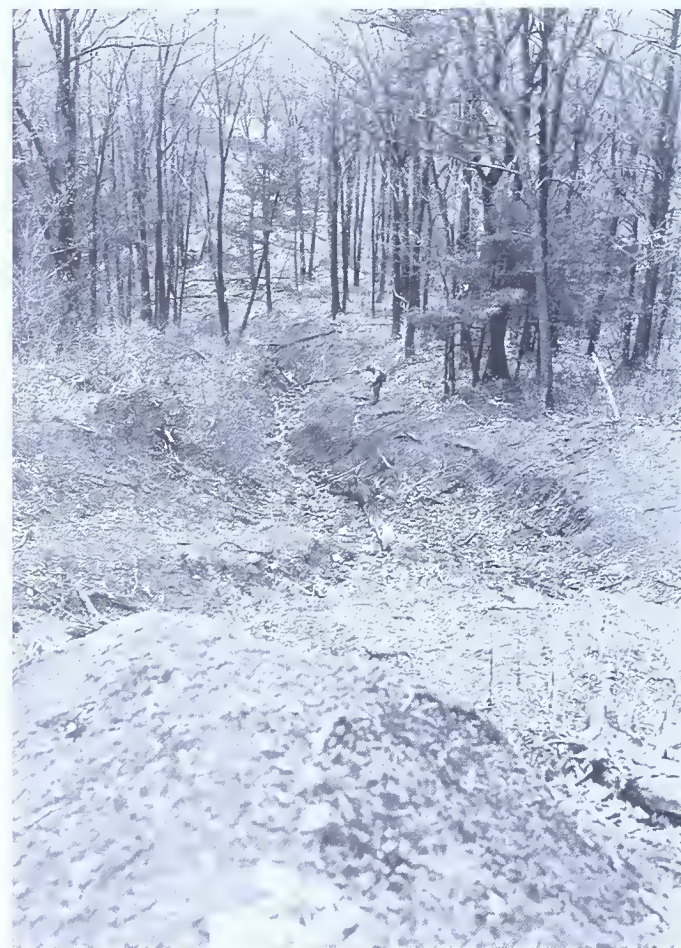
Figure 36. Photograph looking down through the central "chute" portion of the Torbert slide. The person in the center of the photograph provides scale.

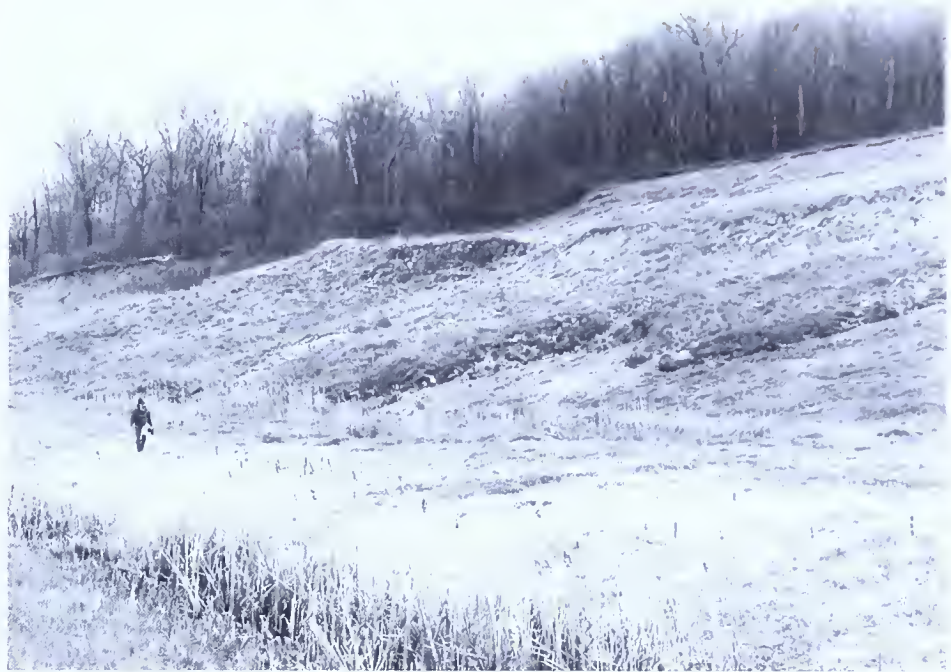
Figure 39. The eastern part of the Lock Haven slide from near the center of the toe. Note the secondary scarps, flow lobes, and cattail growth on top of the slump block and at the toes of flow lobes. The main head scarp is out of view in the woods.

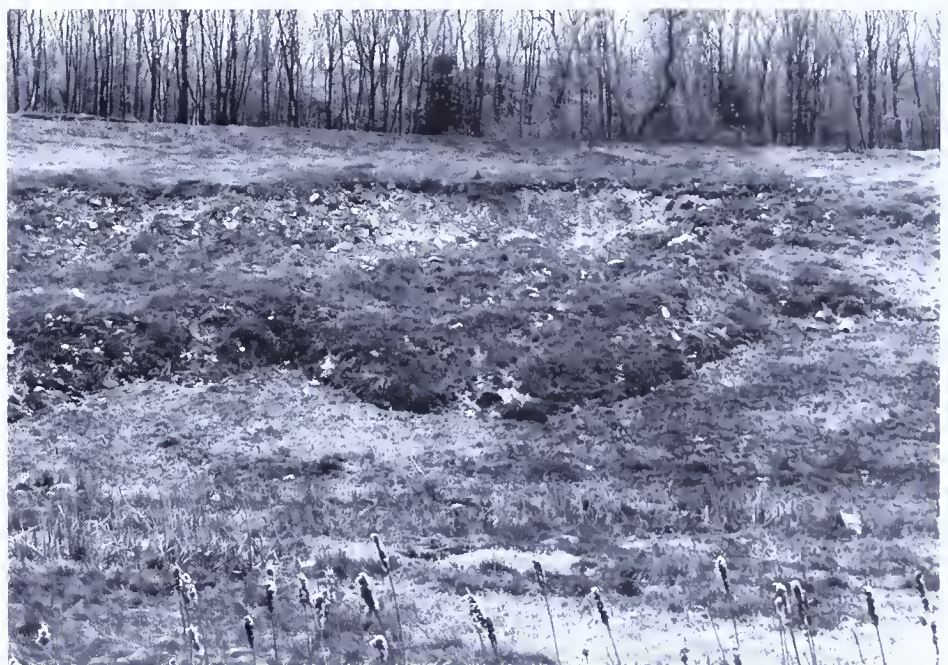
Figure 40. An active minor earthflow in the eastern part of the Lock Haven slide. The slope below the flow was excavated to bedrock during highway construction.

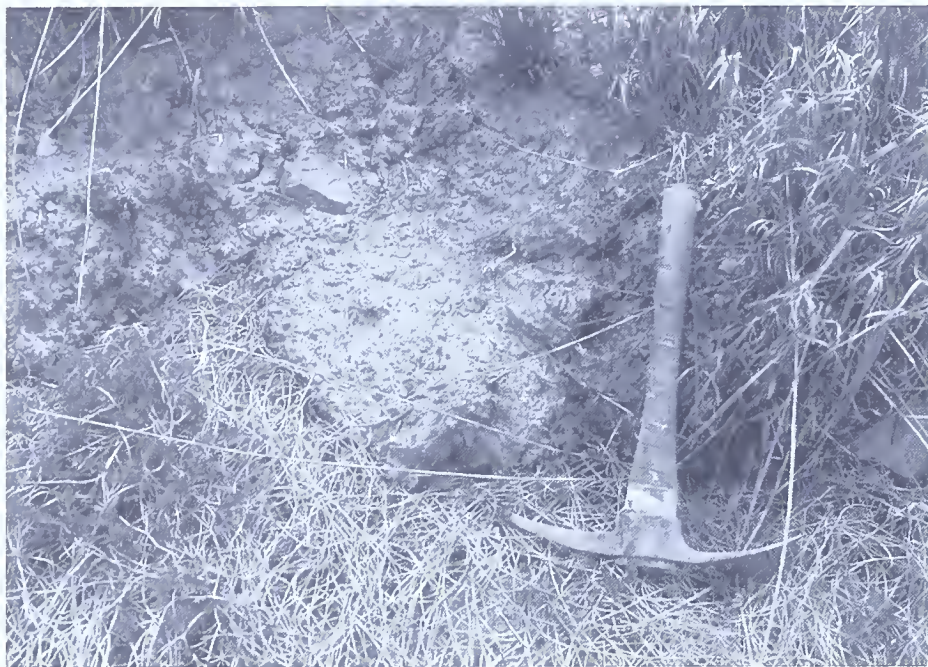
Figure 41. Close-up photograph of the toe of an active earthflow lobe in the Lock Haven slide. The pick is approximately 20 inches long.

The lower portion of the slope was cut to allow highway construction, and a large volume of material has been removed since the initial slide failure. Most of the area within 100 to 150 feet of the road has been cut back to bedrock and is thickly covered with grass and/or crown vetch. The toe of the slide has flowed over the cut bedrock surface (Figure 40). The west end of the slide area has had an extensive drainage system installed. The eastern end is poorly drained, having large swampy areas that support cattail growth, and is actively moving closer to the road edge. The surface is hummocky, wet, and stony and has active small earthflow lobes (Figure 41).

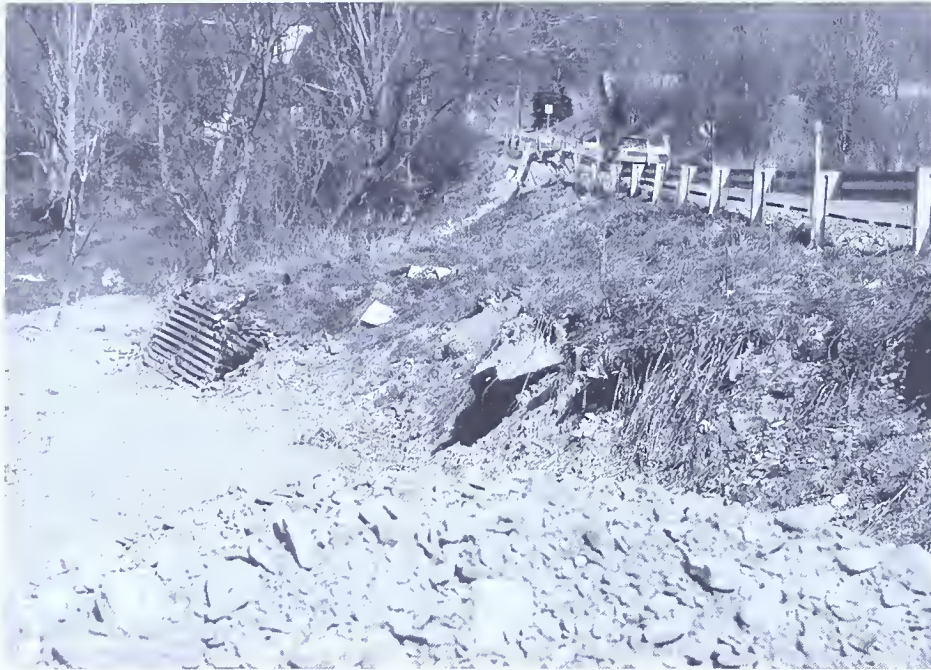
Figure 44. Photograph showing the head scarp of the Sayre slump largely obscured by fill and re-grading in an attempt to maintain the road. The head scarp is in the roadway beyond the guardrail (marked by a dashed line).

road. Addition of fill is the most obvious change, but there is also evidence of test borings and installation of instrumentation. At the west end of the main body of the slide, the contact between lake clays and the overlying till/colluvium is exposed in a minor scarp. The attitude of the varved bedding here indicates that slump blocks have been tipped back into the hillside from the original horizontal bedding. This presumably occurred in an earlier, larger slump than the present one.

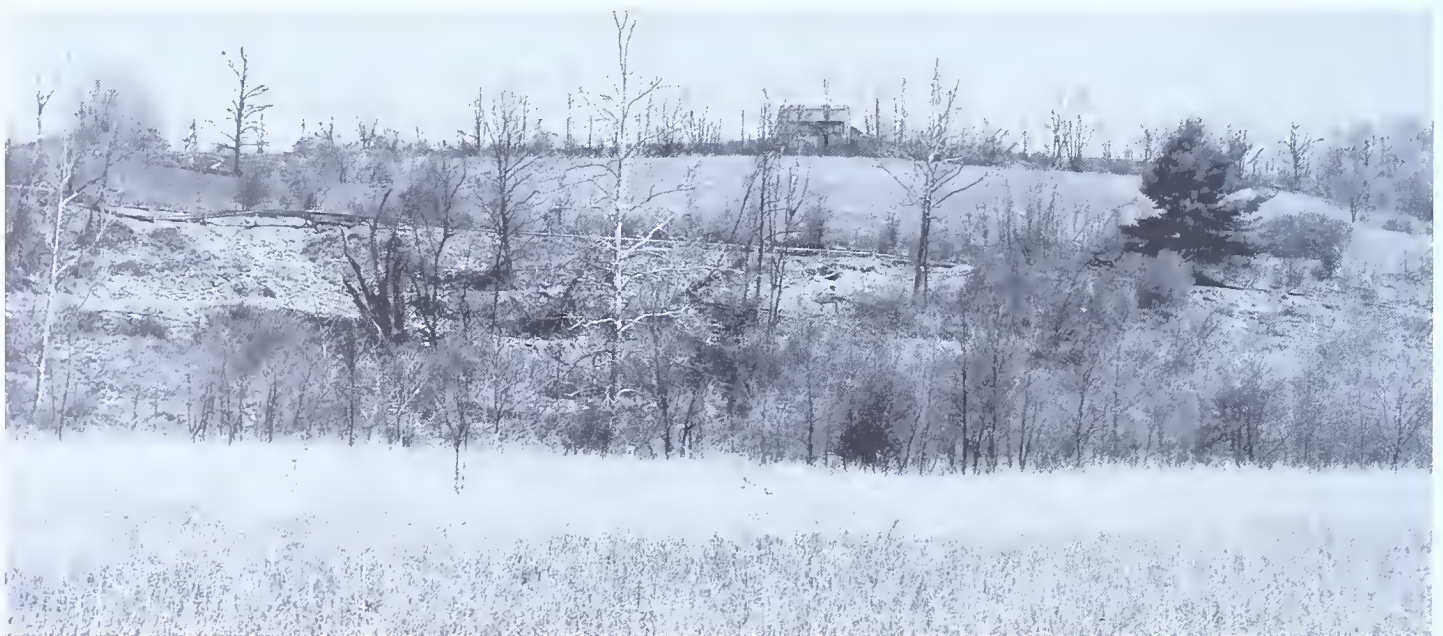
Figure 45. Photograph of the central part of the Sayre slump from across the stream. Damaged guard-rail at left is at the site of Figure 44.

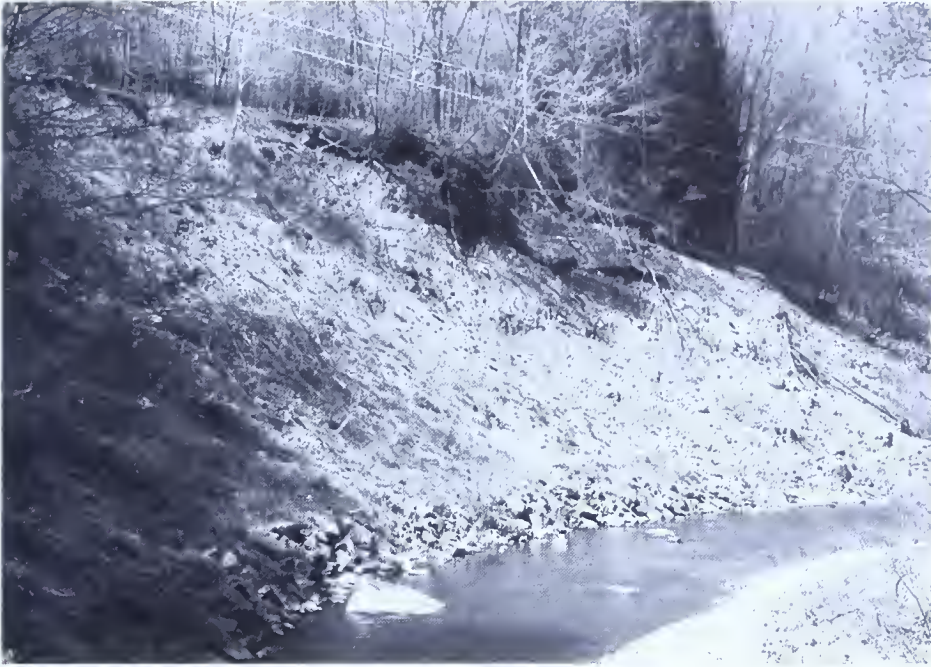
Figure 49. The center portion of the slide near New Albany, showing riprap at the toe and both slump and topple blocks at the head.
